Diagnostic Imaging Review

A 50-year-old man with a serious pain in the neck

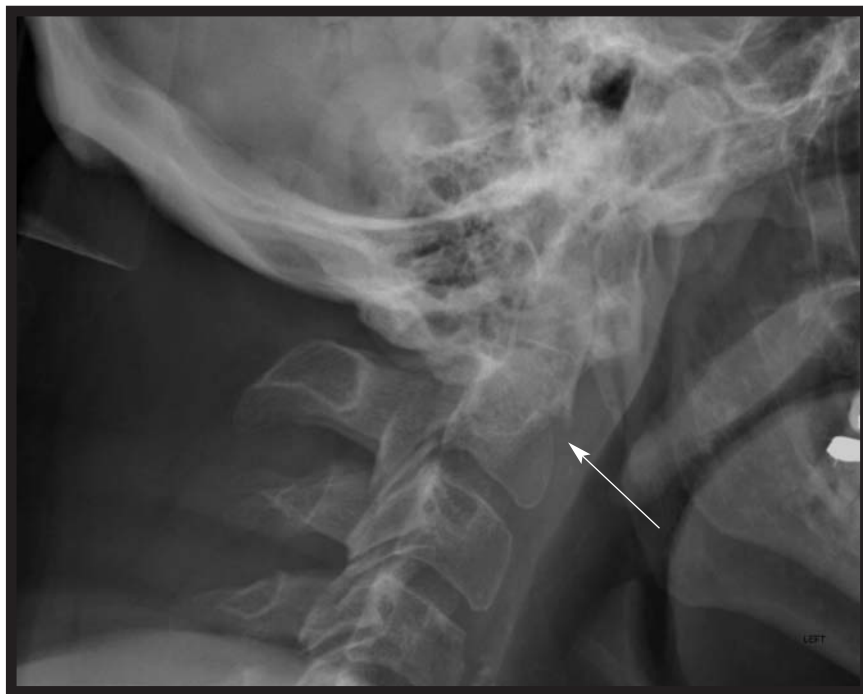
FIGURE 1. The arrow points to a “step-off” deformity of the anterior aspect of C2 at the base of the odontoid, compatible with a fracture.

Figure 1 demonstrates a “step-off” deformity of the anterior cortex of the C2 vertebral body at the base of the odontoid process. The radiograph reveals that the odontoid process is anteriorly subluxed by approximately 2 mm.

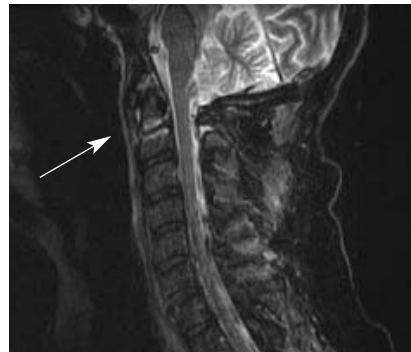
FIGURE 3. MRI in the sagittal plane demonstrates a fracture through C2 at the base of the odontoid process (thin black area), with surrounding edema (white areas on either side of the black area).

for other fractures that may not have been visible on radiographs. Figure 2 is a reconstructed CT image in the coronal plane that confirms the fracture of the odontoid process. The fracture is seen to extend into the body of C2, compatible with a type III odontoid fracture. MRI was also performed and showed no evidence of adjacent spinal cord injury or ligamentous injury, but edema at the level of the fracture was seen (see Figure 3).
